Rail Accident Investigation Branch

Rail Accident Report

**Fatal collision between a tram and a pedestrian,
near Saughton tram stop, Edinburgh
11 September 2018**

Report 09/2019
July 2019

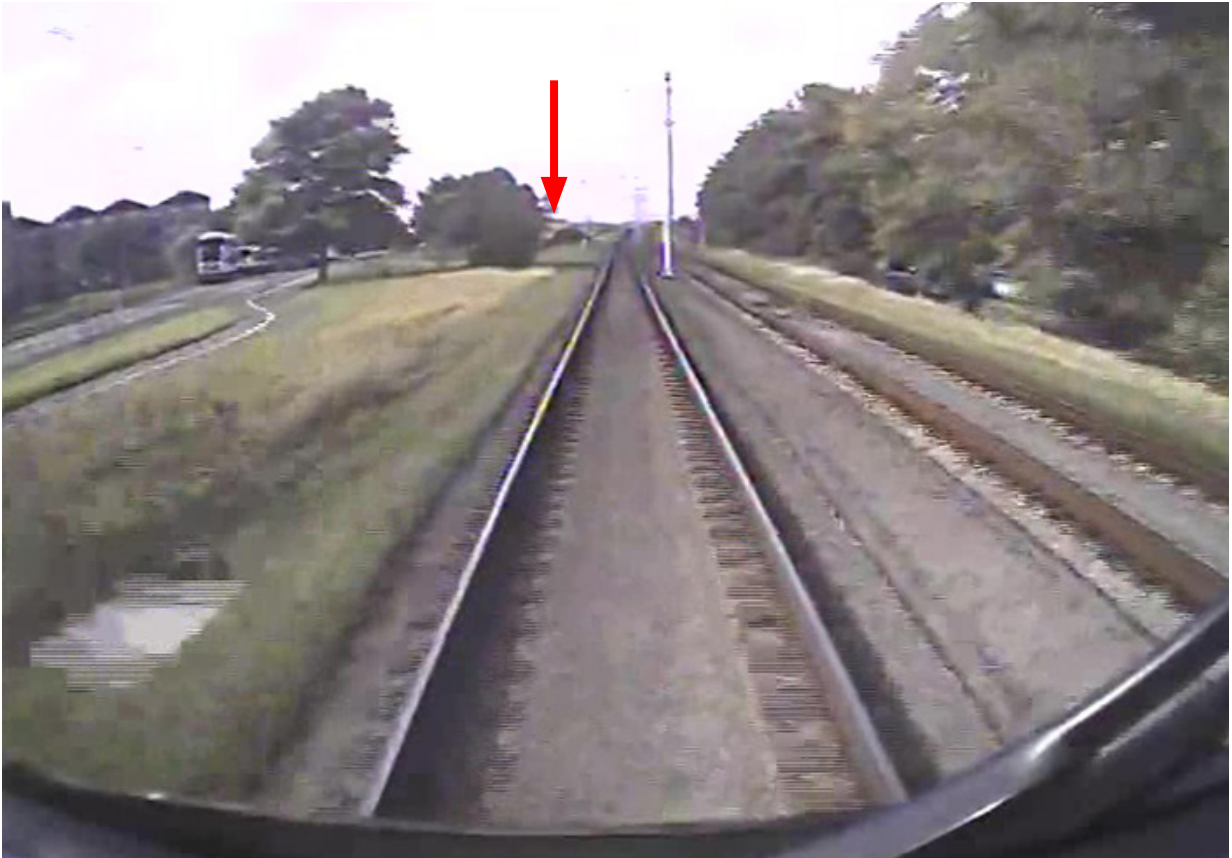
Figure 4: Image from the FFCCTV of tram 260 at around 73 metres from the crossing and 4.6 seconds before the collision. The arrow indicates the location from which the pedestrian emerges very shortly afterwards.

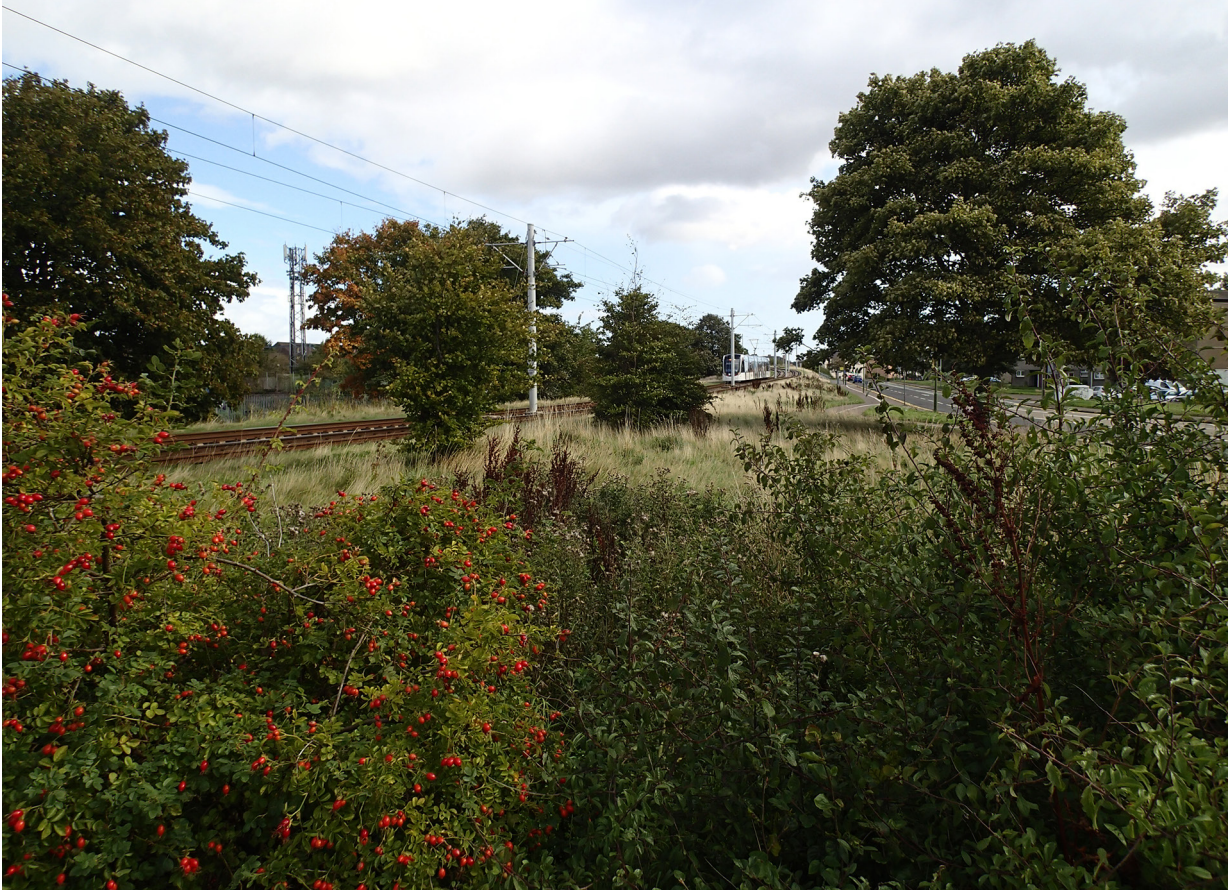
- 43 It is possible that the pedestrian may have looked for approaching trams while he was still some way away from the crossing as he walked towards it. However, clear views of the tramway to the east from the footpath are interrupted by bushes on the edge of the footpath (figure 7) and two trees adjacent to the track (figure 8).

Figure 7: The view to the east from the footpath at 14 metres from the crossing

- 44 The bushes and trees also obscured an earlier sighting of the pedestrian by the tram driver. The trees have since been removed (paragraph 137).
- 45 The pedestrian had passed a D4 medical examination¹ required for driving public service vehicles in May 2017. That type of medical examination includes an assessment of both visual acuity and visual field. Although he had previously been diagnosed with a deep cataract in the left eye, this is not thought to be a factor because his vision was adequate for bus driving. Additionally, the CCTV evidence indicates that he did not turn his head towards the approaching tram just before he started crossing the tram lines.

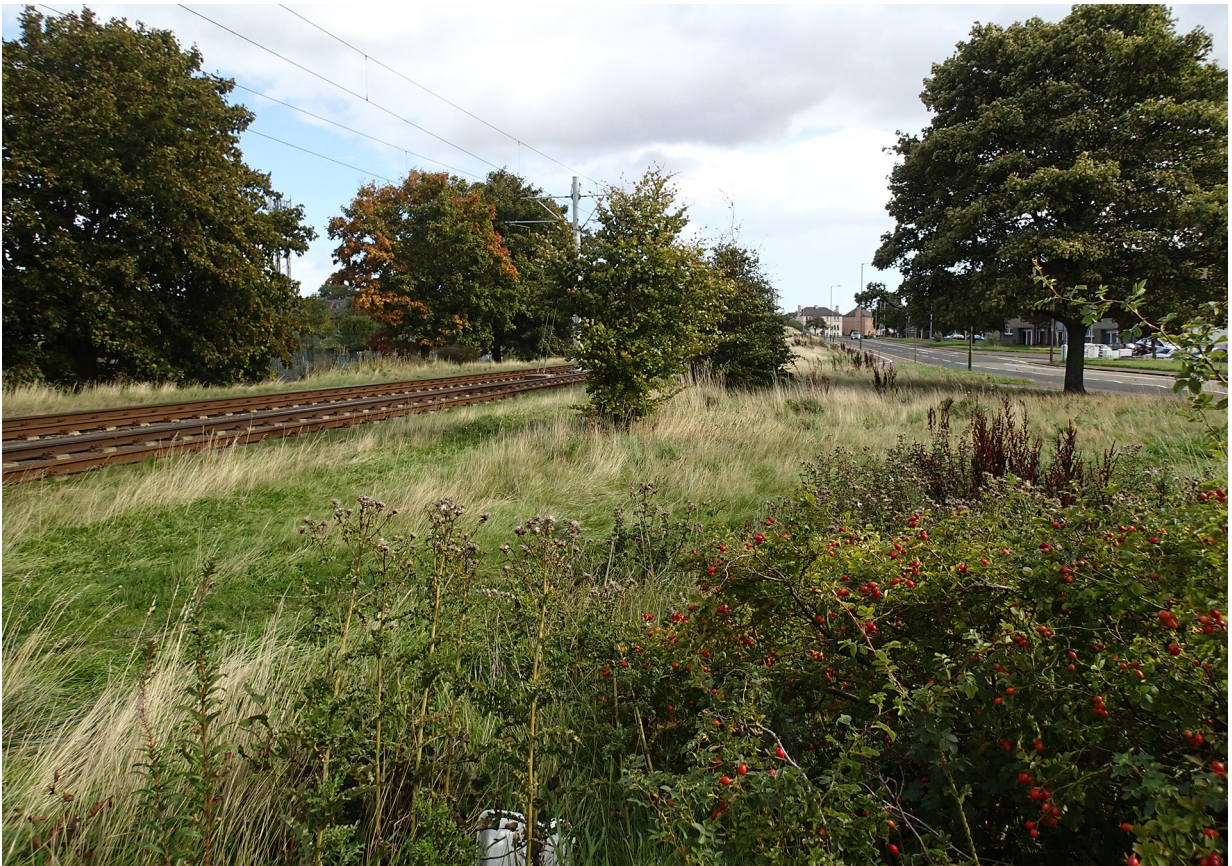
Figure 8: The view to the east from the footpath at 8 metres from the crossing

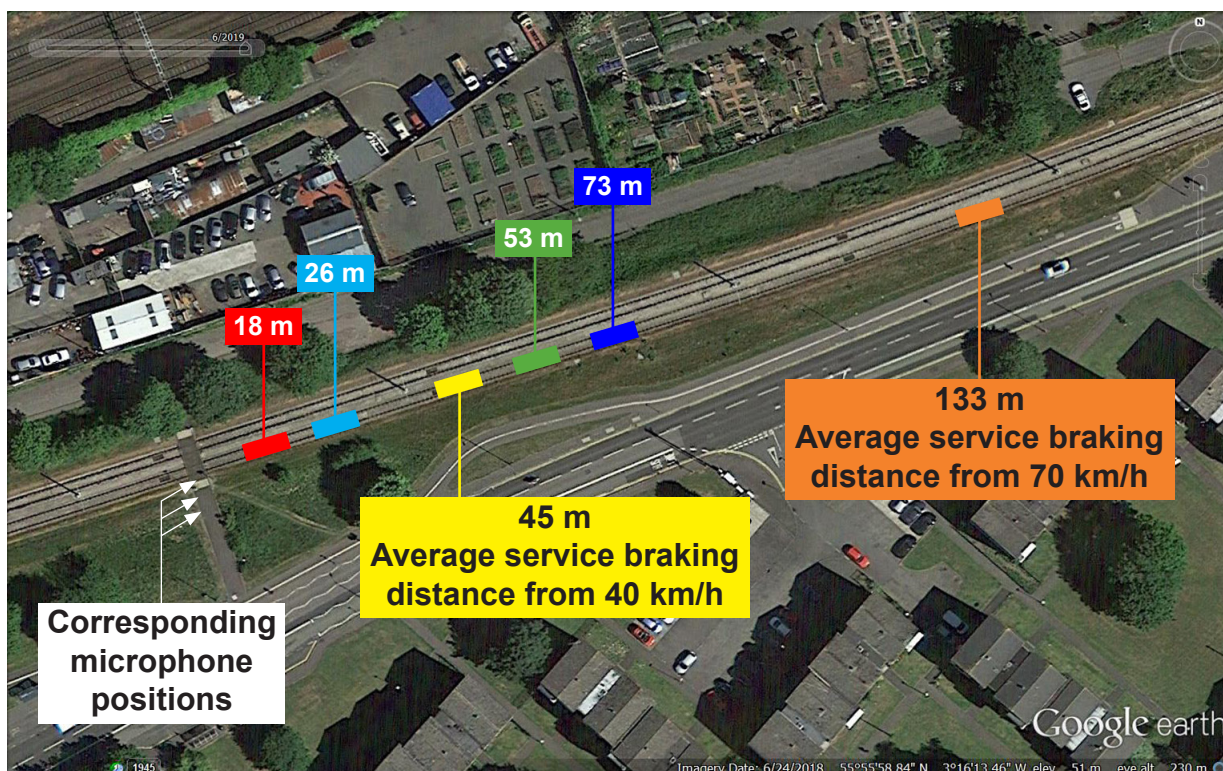
58 Following the accident, the RAIB commissioned a specialist consultant to carry out acoustic measurements to investigate the audibility of the bell as tram 260 approached the crossing (figure 9). Sound pressure level measurements of the tram's horn were also taken as this is an alternative method of warning provided on the tram, although it was not used on this occasion until the tram was very close to the crossing (paragraph 28). Additionally, measurements were taken of the sound pressure levels of the bell and the horn of another tram which were found to be of a similar level as those of tram 260, when both were measured on level ground in the depot.

Figure 9: Distances of tram 260 from the crossing during the sound pressure level measurements
